Trash Reduction Pilot Study #A1 End-of-Pipe Trash Systems

Prepared by:
Watershed Protection Division

LA River Outlet Trash Capturing Units – Pictorial Record of Field Observations

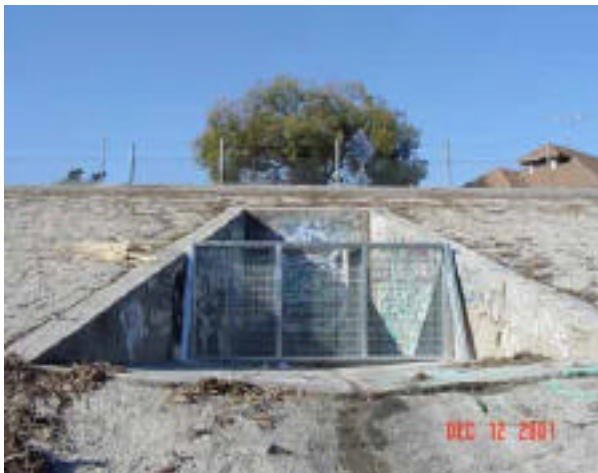
Location # 1

Screen barriers at locations 1, 2, and 3 were installed on the trapezoidal section of the LA River channel. These screen barriers were placed two to three feet from the end of the outlets. Location 4 has a screen basket size of 2.75'L x 3.75'H x 2.25' W that is anchored onto the channel wall directly in front of the outlet opening. Location 5 has a fully enclosed screen basket 15.5' L x 7.5' H x 3' W anchored onto the wall and floor of the channel directly in front of the outlet opening.

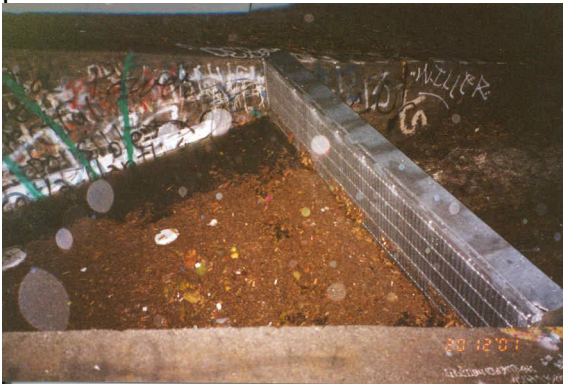
Location 1 – Duvall and Blake

Observations were made at 9:45 pm. Three quarters of the height of the screen were clogged. Flow was trickling through the screen and from the bottom. See picture below.

- For the four existing units (locations 1, 2, 3 & 5), replace the 5 mm opening mesh with mesh that has 1-inch openings.
- For location 4, keep the 5 mm opening mesh.

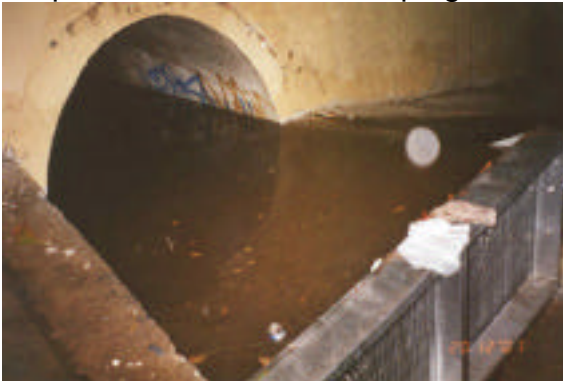
Location 2 - Fletcher Street Bridge

Observations were made at 9:30 pm. The surface of the screen had fully clogged with very little flow trickling through the screen. Almost all the flow along with any suspended matter was escaping the screen from the side. See picture below.

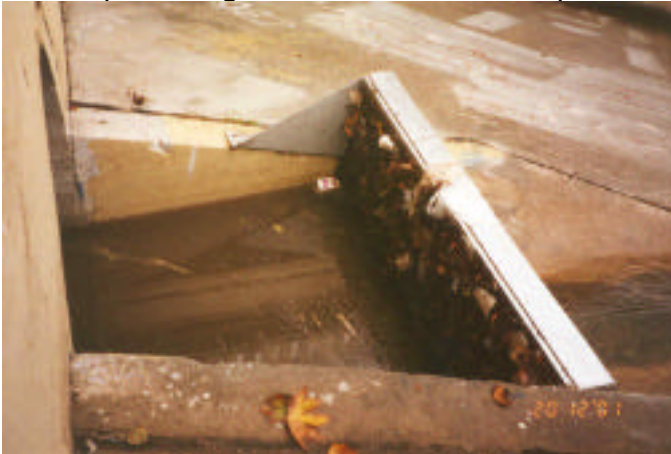
Location 2 - Fletcher St. Bridge

The entire screen was covered with debris. There were signs of overflow over the top of the screen, and along the sidewall of the containment area. Trapped stormwater runoff was flowing through the trapezoidal void between the bottom of the screen and the existing concrete slab. Captured trash and debris was not escaping through that void. The debris was scraped off the screen to allow the trapped runoff to drain. After the flow drained, three to four inches of sediment were found at the bottom of both the containment area and the invert of the outlet pipe for a length of approximately 40 feet. An unspecified amount of trash was also captured against the screen. See picture below.

- Minimize the void between the outlet invert and the bottom of the screen.
- Plan maintenance after every rain event that is 0.25 inch or higher and record the amount of trash.

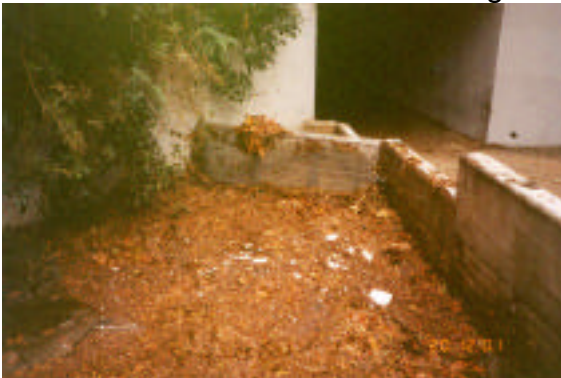
Location 3 - Griffith Park

Large quantities of leaves with very little trash were found in the containment area of this screen. There were signs of overflow over the top of the screen.

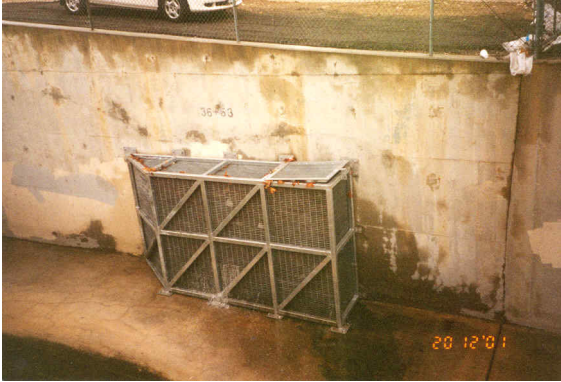
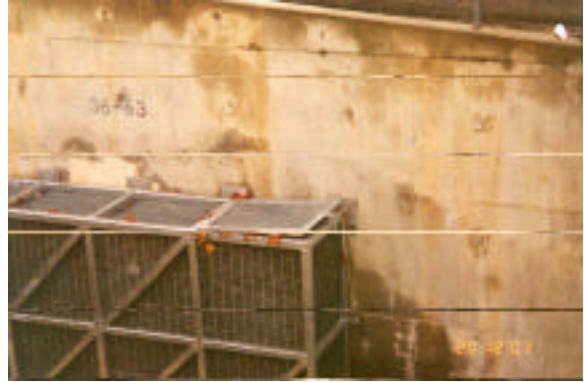
Location 5 - Chatsworth

- Flooding is not a concern at location 1 (Elysian Park), location 2 (Silver Lake), location 3 (Griffith Park) and location 4 (Studio City). The fifth location (Chatsworth) may result in upstream flooding because it is fully enclosed and will not allow flow to bypass the unit.

There were signs of overflow through the access cover located at the top of the screen cage. It was difficult to determine how full the basket was. It was estimated to be about one third of its height. See pictures below.

- Remove the 5mm wire mesh from the cover section of the fully enclosed unit located at Chatsworth area (location 5). In the event of flow reaching the top of the unit, the primary screen will allow more flow to escape, thus, limiting upstream flooding.

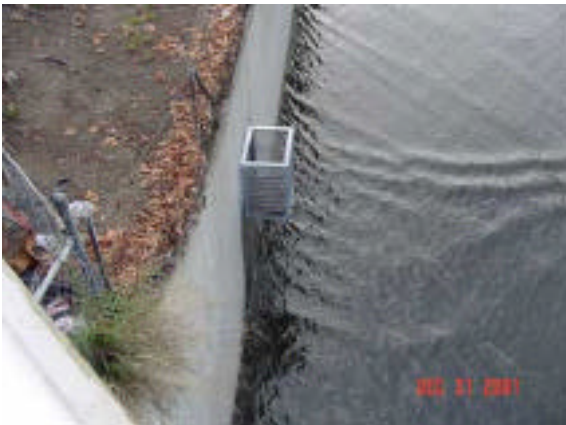
Location 4 – Studio City

The screen at the location 4 was installed.
