**CITY OF LOS ANGELES
DEPARTMENT OF PUBLIC WORKS
LA SANITATION AND ENVIRONMENT**

**30-DAY REPORT
ON
UNPLANNED DISCHARGE TO 1-MILE OUTFALL OF
UNTREATED WASTEWATER ON JULY 11 AND 12, 2021**

**HYPERION TREATMENT PLANT
12000 VISTA DEL MAR, PLAYA DEL REY, CALIFORNIA
(NPDES PERMIT NO. CA0109991, ORDER NO. R4-2017-0045)**

AUGUST 13, 2021

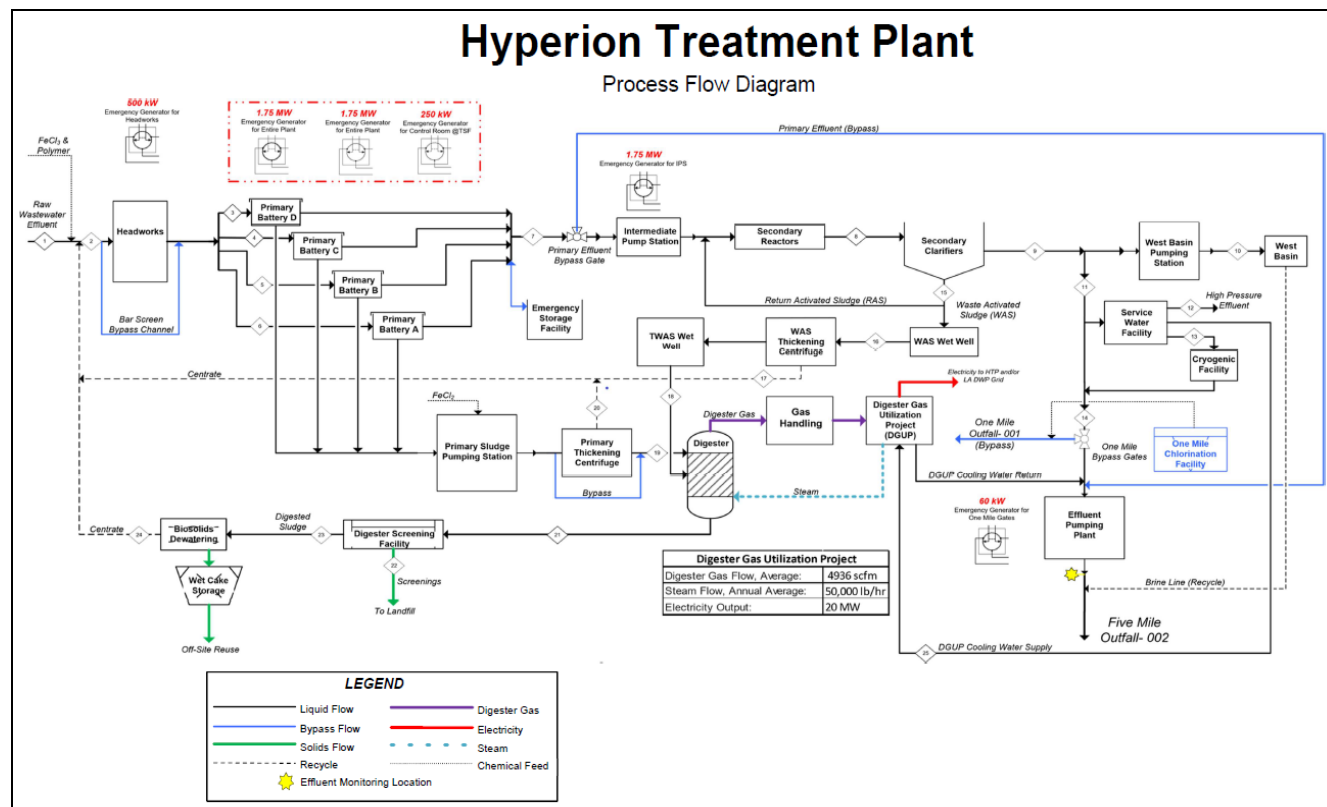
Figure 2 – Hyperion Process Flow Diagram

Hyperion has a design treatment capacity of 450 MGD, with peak wet weather capacity of 850 MGD. Due to water conservation efforts and water recycling at the two upstream water reclamation plants, its influent dry weather flow has decreased from 350 MGD in early 2000s to the current average level of 260 MGD. A schematic of the wastewater treatment process at Hyperion is shown in Figure 2.

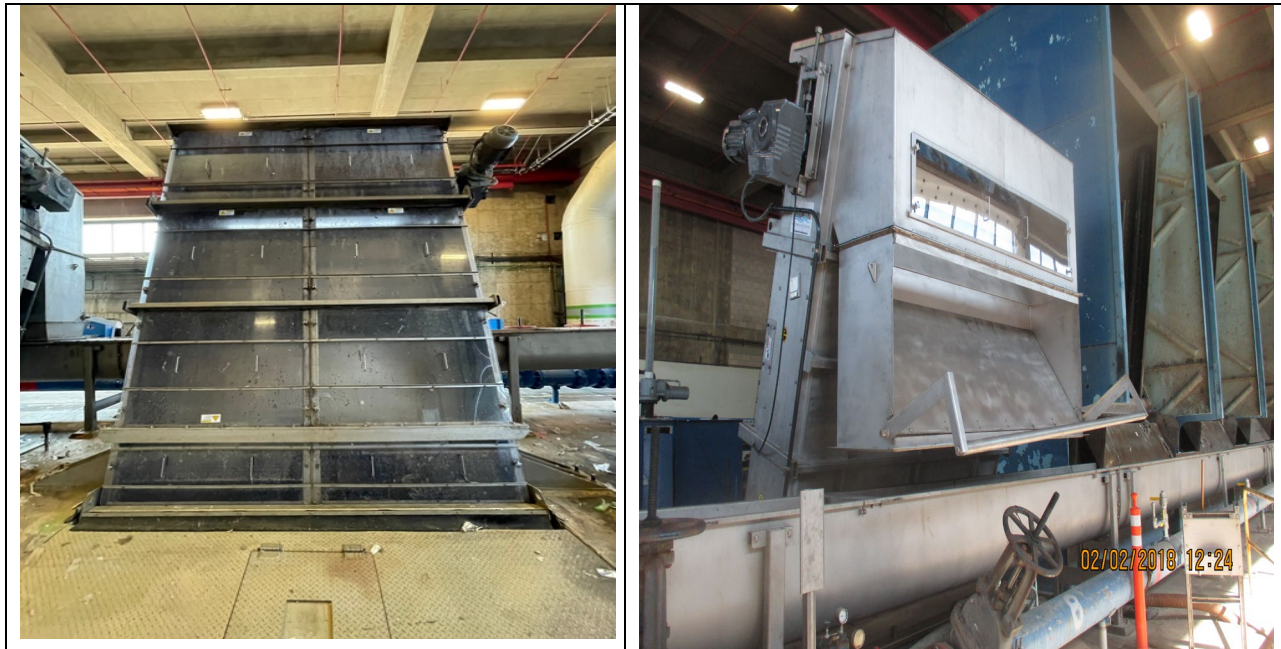
Figure 4 – Hyperion Mechanically-Raked Barscreens Installed in June 2019

All materials (including but not limited to bolts, anchor bolts, nuts, and washers) are Type 316 stainless steel suitable for service in a moist, corrosive environment as encountered in wastewater treatment plants.

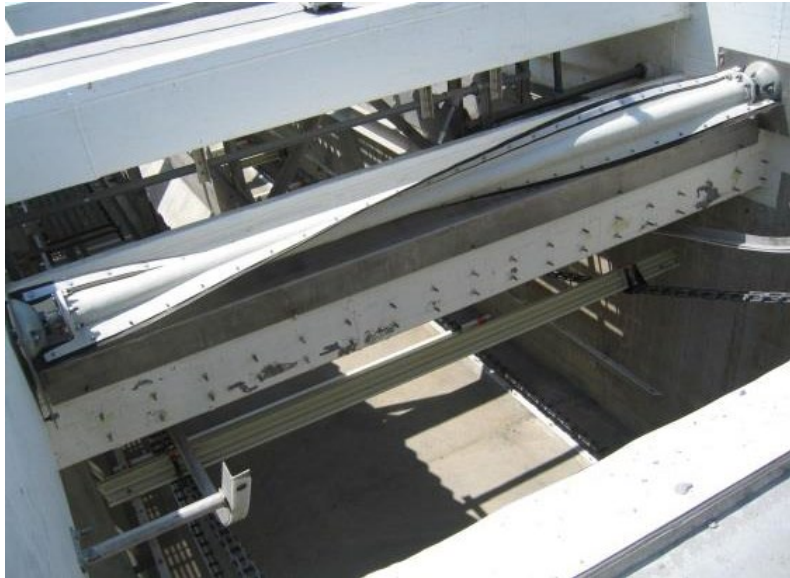
Figure 6 – Primary Tank Skimmers

materials that do not readily flow, flushing water is used to move scum along the scum trough to the scum wet-well. From the wet-well, the scum is pumped to the Primary Sludge Pump Station where it is blended with the primary sludge, and then the mixture is conveyed to the anaerobic digesters. From the digesters, the digested sludge is screened to remove trash and debris at the Digester Screening Facility before land application. The trash and debris in the digested sludge are removed and hauled to landfill for disposal.

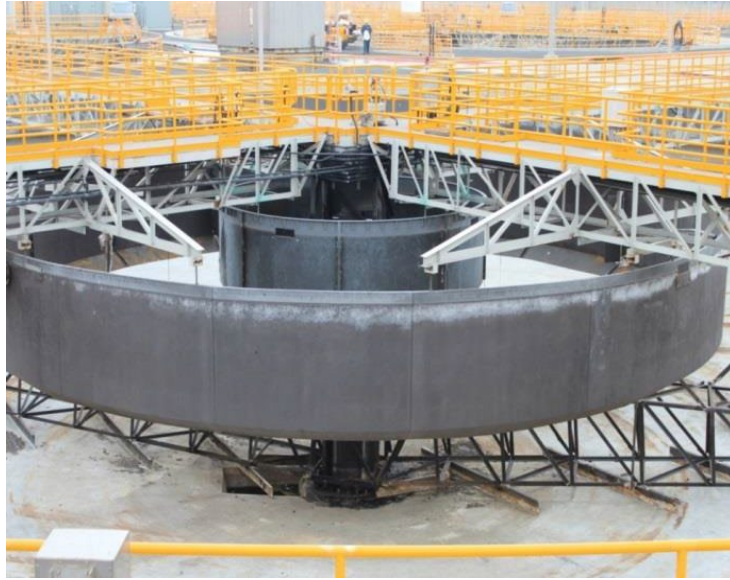
Figure 7 – Hyperion Secondary Clarifiers

In the flocculation and settling zones of each clarifier, there is a rotating skimmer pipe with opening on the top. The rotating skimmer rotates down each time the skimmer flight passes through the area. The scum flows in the skimmer pipe and discharges to scum wet-well. From the wet-well, the scum is pumped to the Headworks to go through the treatment processes.

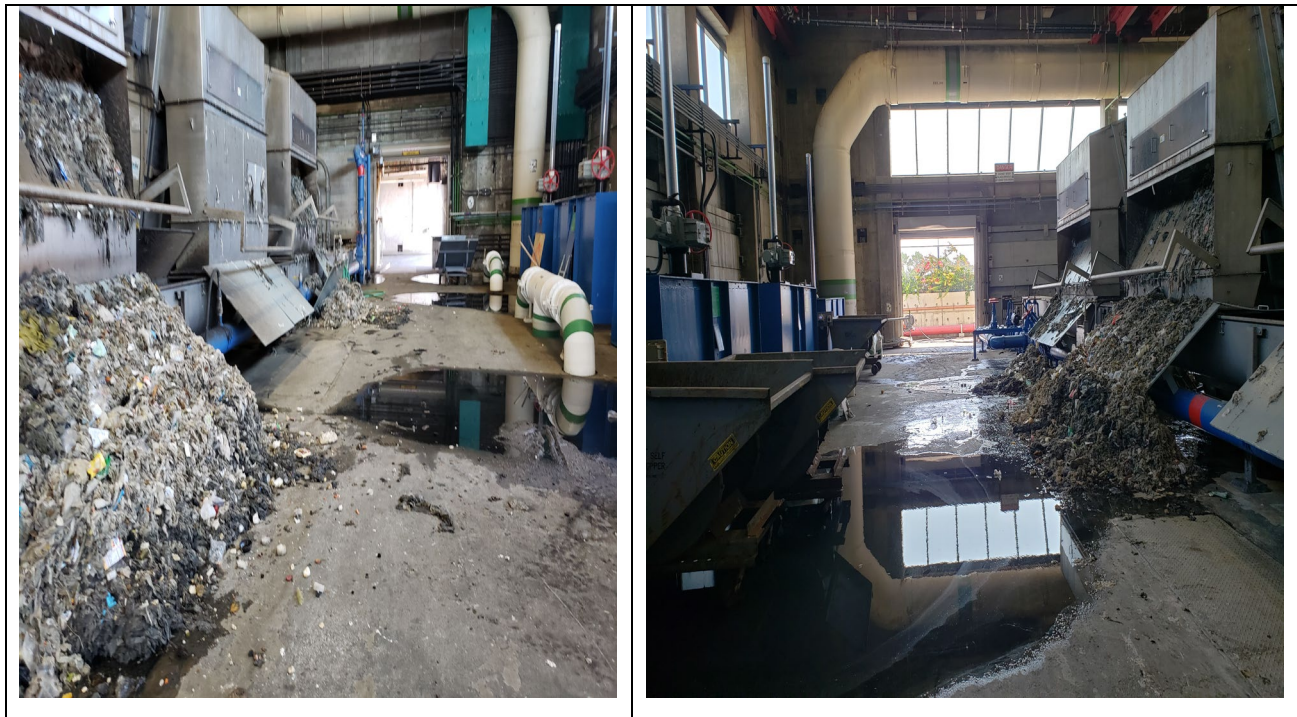
Figure 13 – Hyperion Headworks Barscreens with Excessive Trash and Debris

On July 11, 2021, Sunday, excessive amounts of trash and debris in the untreated wastewater collected on the barscreens at the Headworks Facility (Figure 13), resulting in flooding of Hyperion and untreated wastewater to overflow (Figure 14). This resulted in approximately 17 MG of untreated wastewater reaching the ocean through Hyperion’s emergency 1-Mile Outfall. LASAN staff continue to investigate the source of this debris.

It is our conclusion that the unplanned discharge of approximately 17 million gallons of untreated wastewater into Santa Monica Bay through the 1-Mile Outfall on July 11 and 12, 2021 was caused by inundation of the Headworks barscreens with quantities of unexpected debris. Upon becoming aware of the situation, LASAN addressed the issue with the utmost urgency and immediate response measures were implemented to mitigate the impact of the spill. LASAN will continue to work proactively to maintain its mission of protecting public health and the environment and that includes the precious Santa Monica Bay.

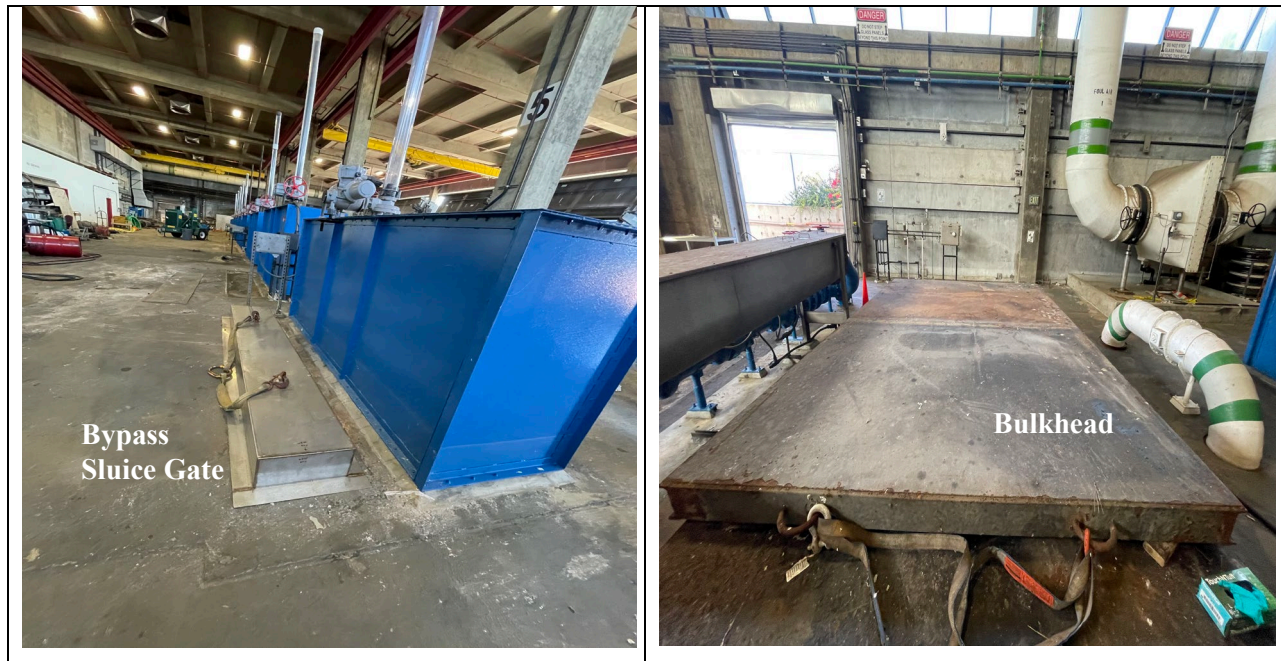
Figure 15 –Bypass Sluice Gate (Left) and Bulkhead (Right)

After all efforts were exhausted in getting the barscreens online, the operators attempted to open the headworks emergency bypass gate around 4:30 PM to allow incoming untreated wastewater to bypass the plugged barscreens. However, they had difficulty to remove the bulkhead upstream of the bypass sluice gate (Figure 15) possibly due to accumulation of trash and other debris preventing its removal. Operators were walking around using push brooms and squeegees to make sure they were not going to fall in any open holes.

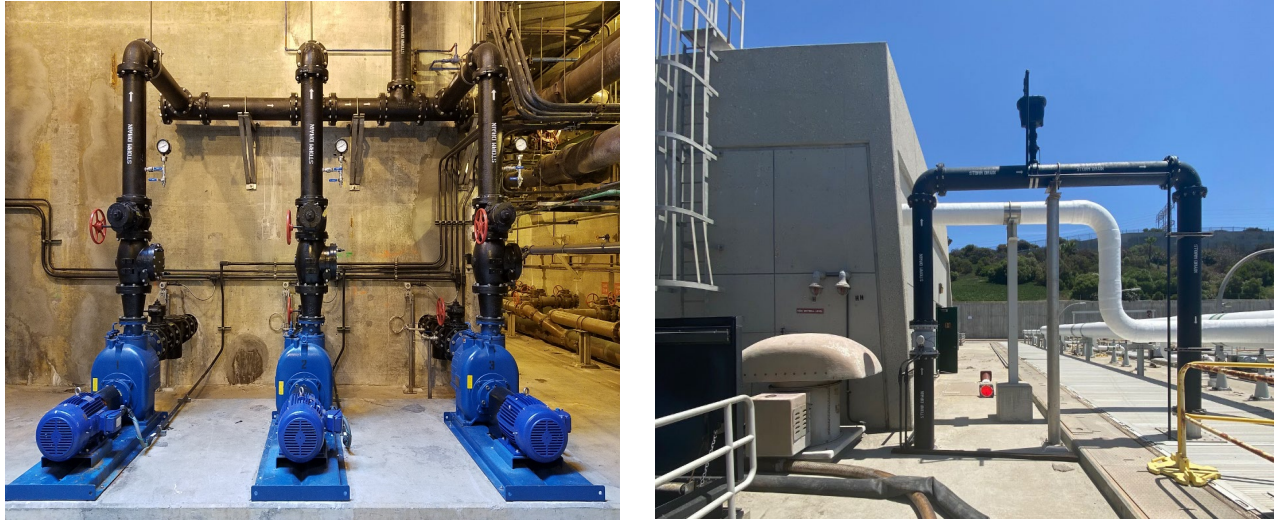
Figure 23 – CSD No. 4 Pump Room (Left) and Effluent Piping to PBD (Right)

The 2017 Central Storm Drain Rerouting Project converted the existing sludge wet well to collect and transfer stormwater from North of 7th street to the primary influent channel. This project was completed in September 2020. The resulting drainage area for this project was about 14 acres. This project reduced the drainage area of CSD No. 2 by 30%. During the spill, 270,000 gallons was collected and pumped to PBD. Unfortunately, the pump room flooded and stopped the pumps. More of the water would have been collected and pumped to PBD. Figure 23 show the CSD No. 4 pumps and piping to PBD.

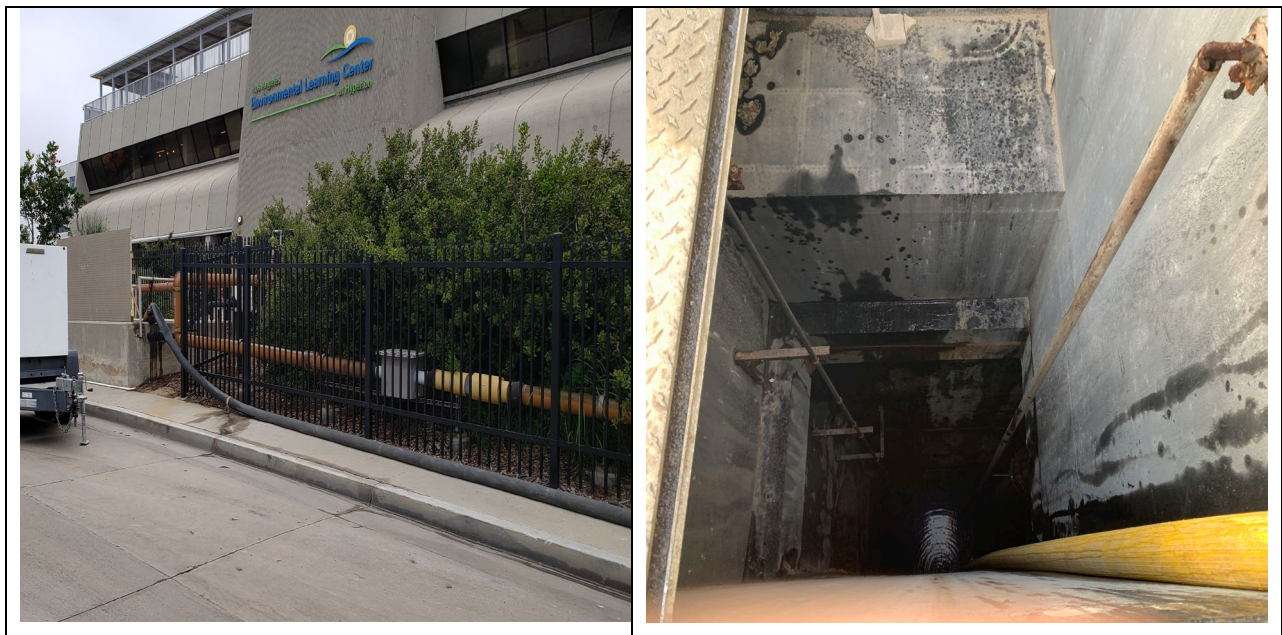
Figure 25 – Pump Located Within 1-Mile Diversion Structure and Surge Chamber

A temporary pump-down system was set up between the 1-Mile Surge Chamber and the Service Water Facility Backwash Wet Well. The submersible pump is capable of pumping 250 GPM or 0.36 MGD. Figure 24 illustrates the schematic for the location of the submersible pump and the pipe routing to the SWF. Figures 25 and 26 show the actual deployment of the pumping infrastructure utilized during the pump-down process.

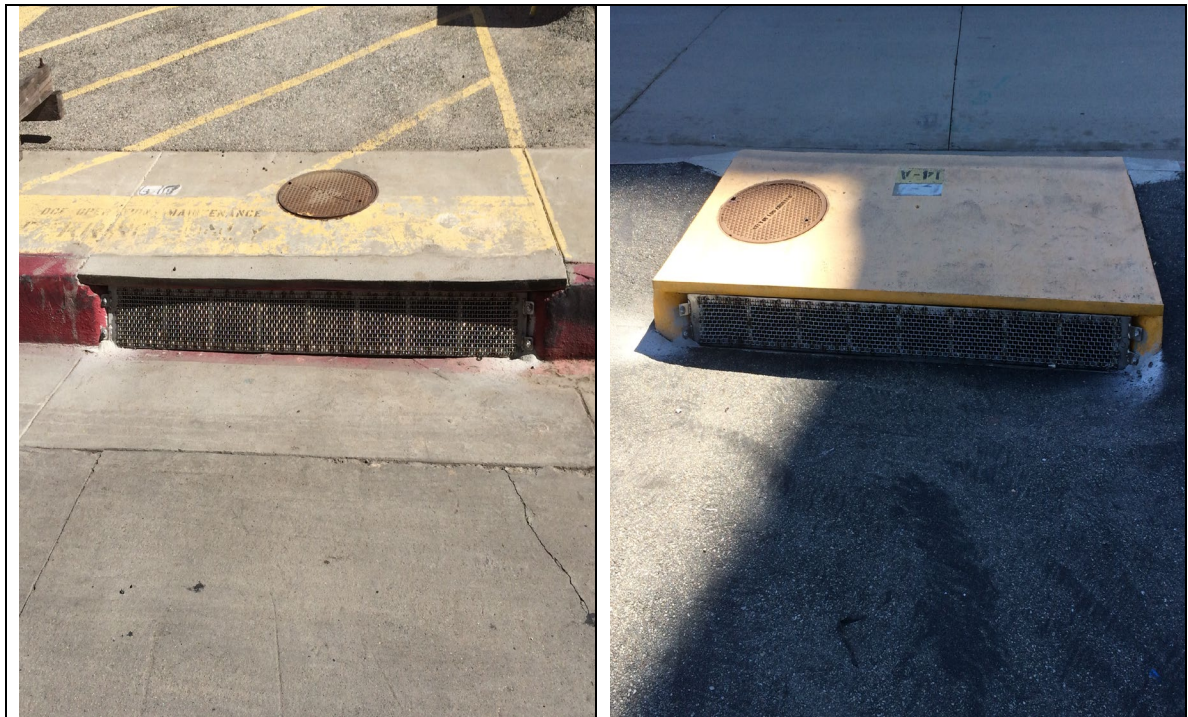
Figure 29 – Storm Drain System & Catch Basins

- Installation of screens on all catch basins in the plant which was completed in 2015 (Refer to Figure 29)

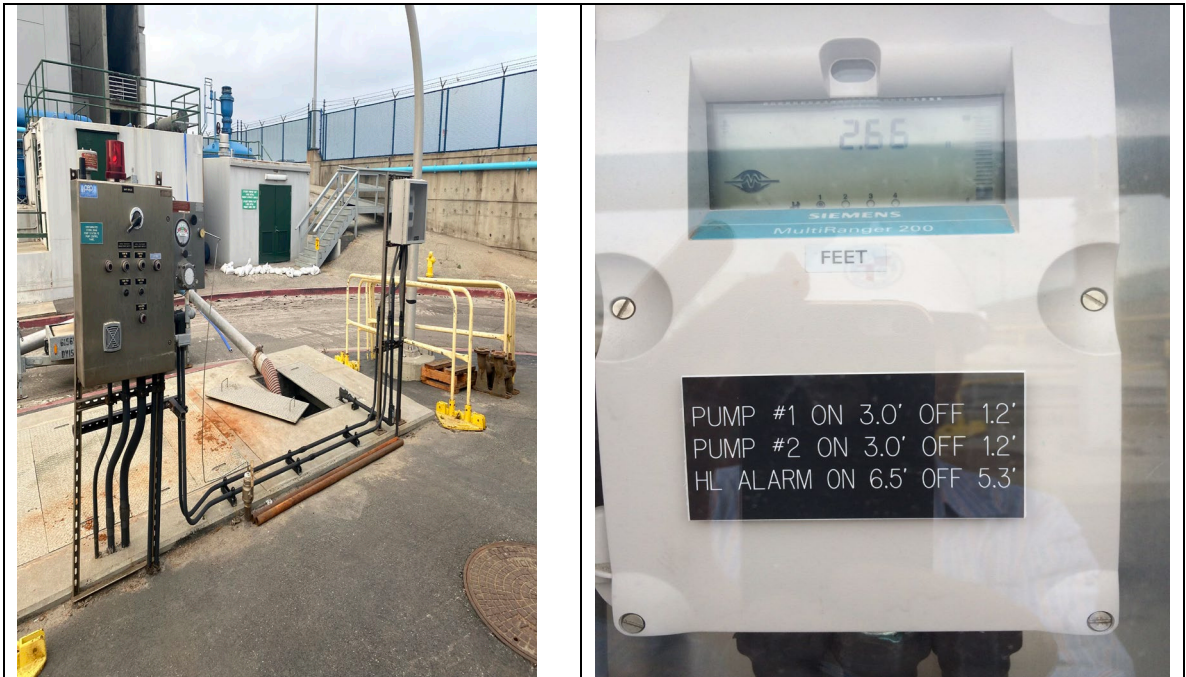
Figure 30 – CSD No. 2 (Left) and Level Sensor (Right)

- New Storm Drain monitoring sensors and level indicator was installed in 2015. (Refer to Figure 30)

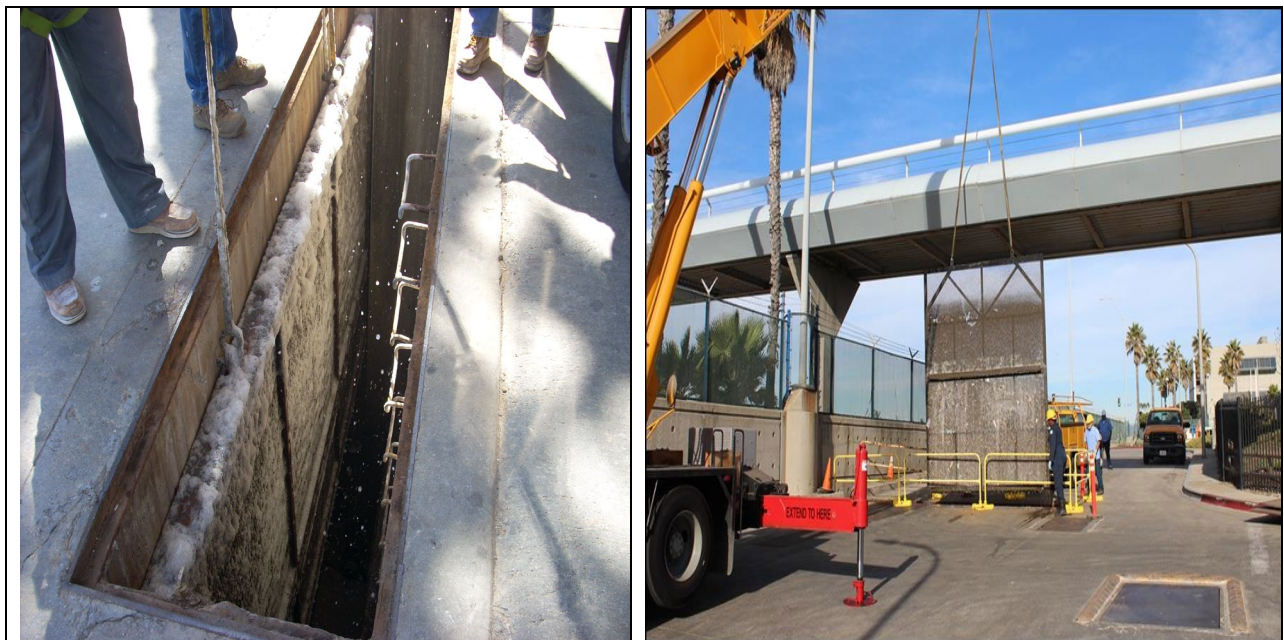
Figure 31 – Secondary Effluent Channel Screens

- Secondary Effluent Channel Screen was installed downstream of the secondary clarifiers in 2015. (Refer to Figure 31)

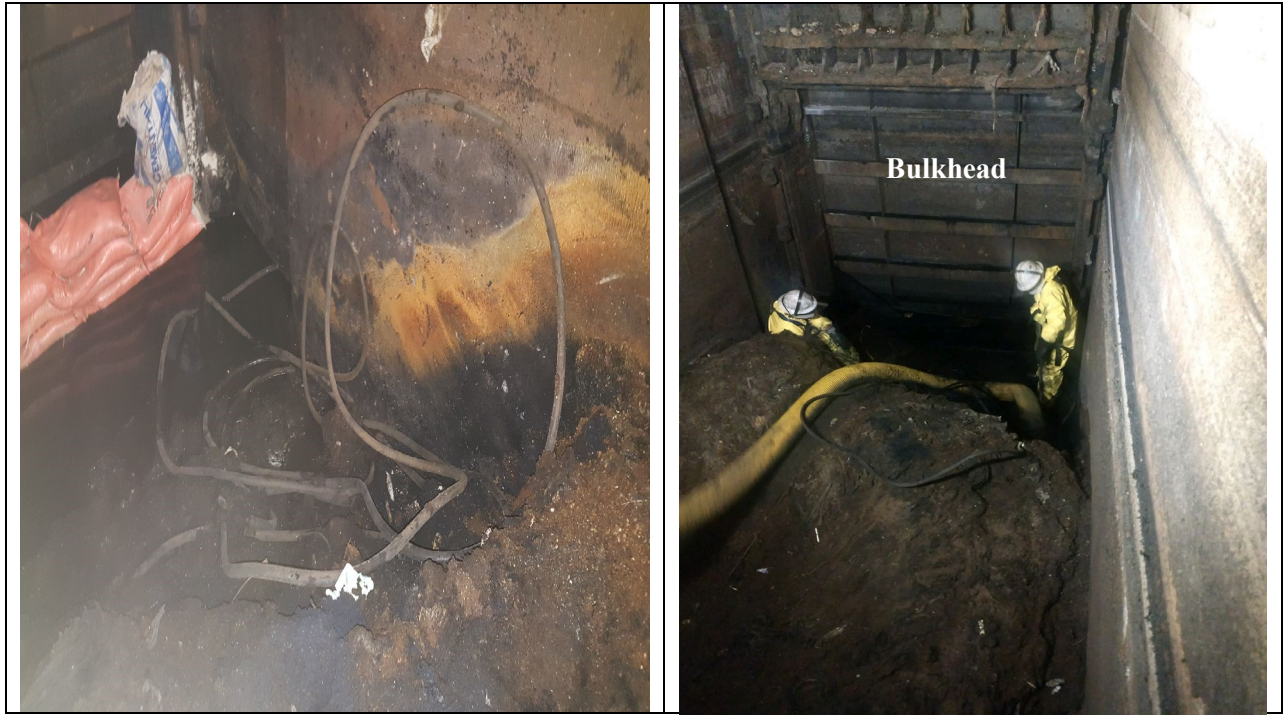
Figure 32 – Headworks Barscreen Bypass Channel

- Headworks Bypass Channel Project was completed in May 2019. (Refer to Figure 32)

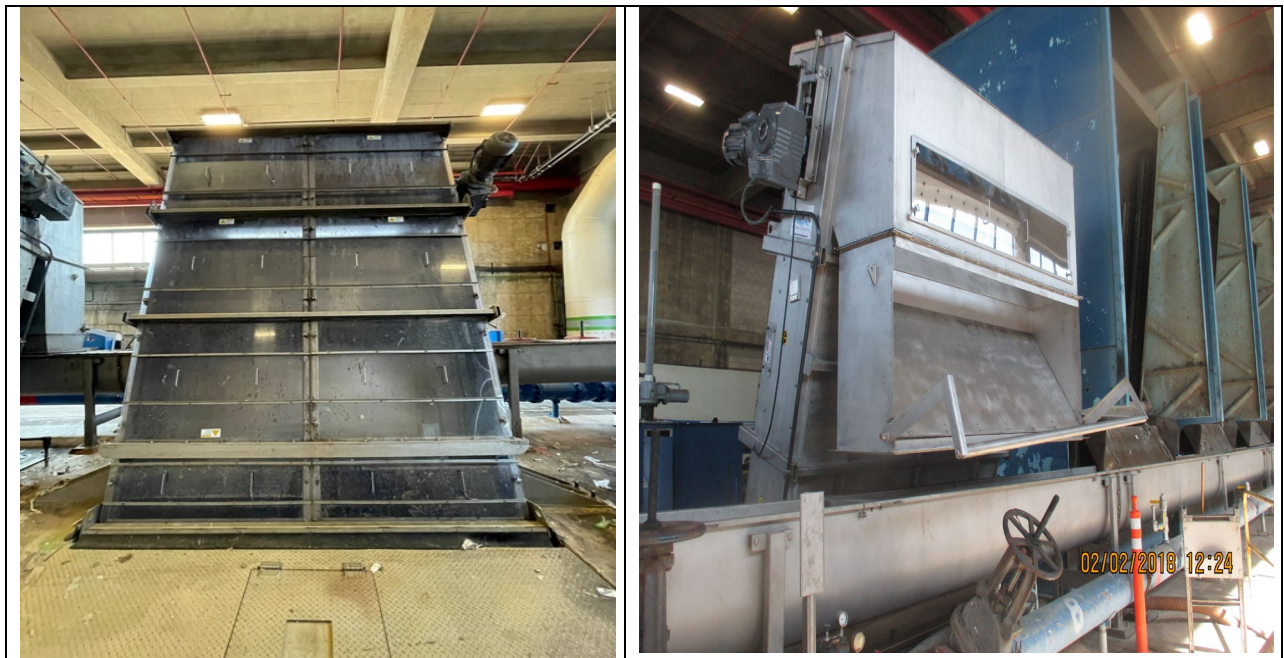
Figure 33 – Headworks Barscreen

- Headworks Barscreens Improvement Project was completed in June 2019. (Refer to Figure 33)

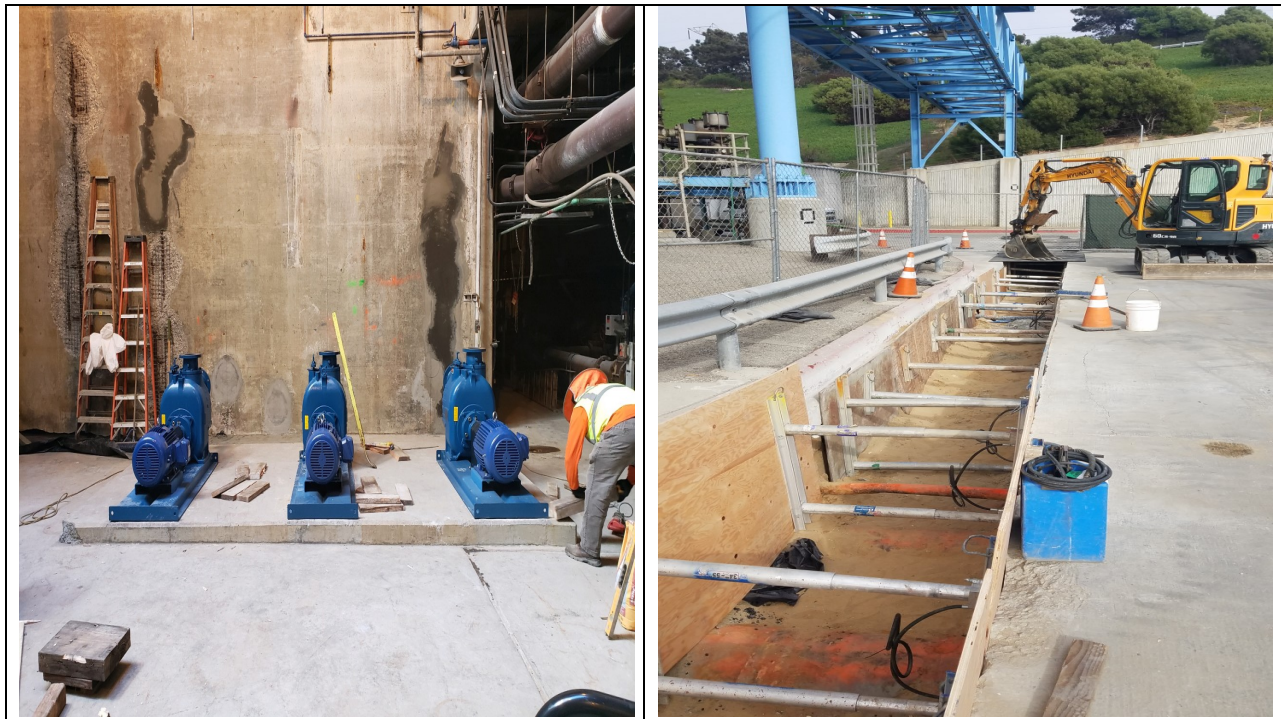
Figure 34 – Central Storm Drain Rerouting Project

- Central Storm Drain Rerouting Project was completed in November 2020. (Refers to Figures 34 and 35)
